Big Star Lake 2018 Aquatic Vegetation, Water Quality, and 2019 Management Recommendations Report

December, 2018

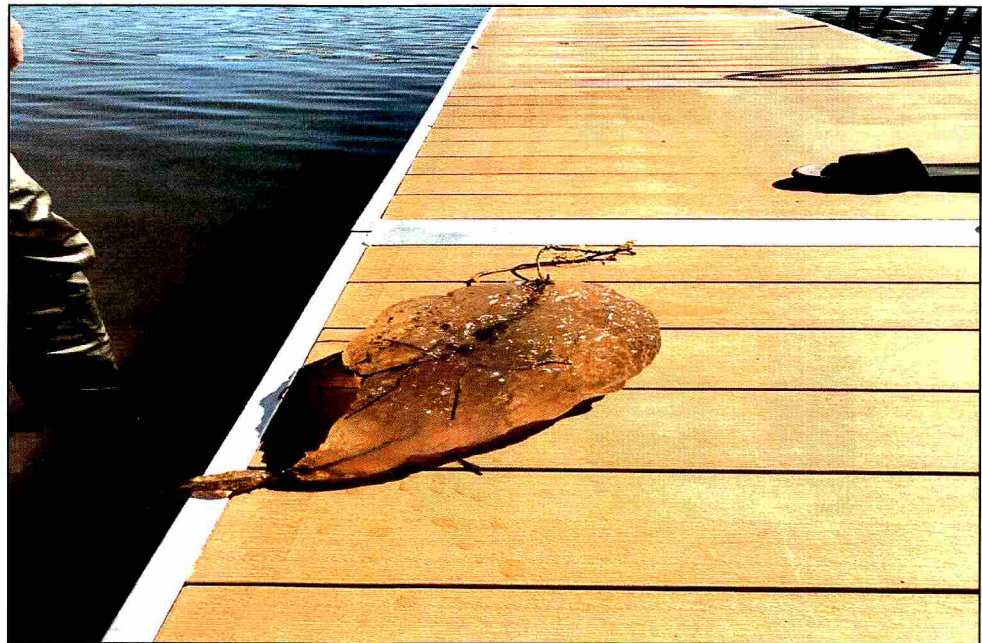
previous years as well and was moderately low even at the lake bottom. The total nitrogen in considered moderate as well. There were some large bryozoans (shown below in Figure 1) that were found in the water. These are like freshwater corals that form mucilage-like outer layers around them to keep them moist and to be able to trap algae to feed on. They are an indicator of productive yet healthy lakes. Though unsightly, they are harmless.

Figure 1. A freshwater bryozoan found in Big Star Lake.

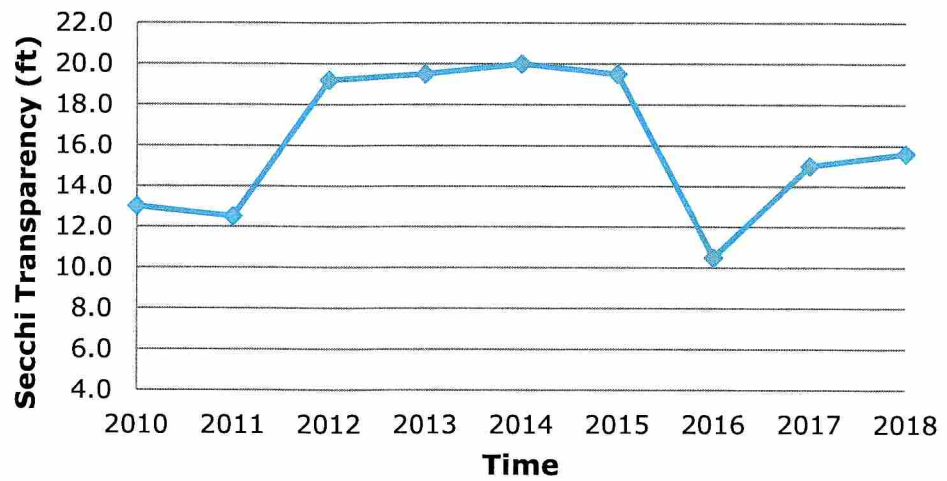
Trend in Mean Secchi Transparency in Big Star Lake

Elevated Secchi transparency readings allow for more aquatic plant and algae growth. The transparency throughout Big Star Lake was adequate in 2018 (12-19.5 feet; below graph) to allow abundant growth of algae and aquatic plants in the majority of the littoral zone of the lake. Secchi transparency is variable and depends on the amount of suspended particles in the water (often due to windy conditions of lake water mixing) and the amount of sunlight present at the time of measurement. Other parameters such as turbidity (measured in NTU's) and Total Dissolved Solids (measured in mg/L) are correlated with water clarity and show an increase as clarity decreases. The turbidity and total dissolved solids in Big

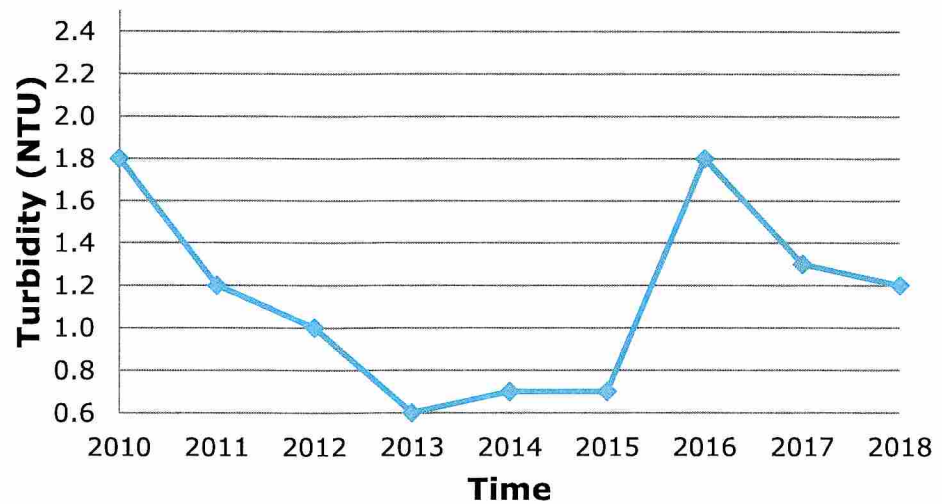
Trend in Mean Turbidity in Big Star Lake

Star Lake have been quite low at ≤ 1.9 NTU's (below graph) and ≤ 68 mg/L, respectively during the recent period which is highly favorable.

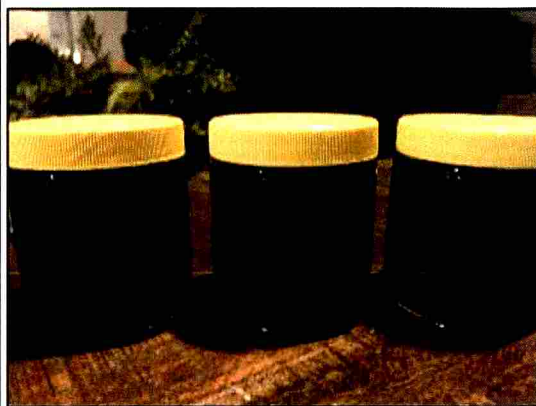
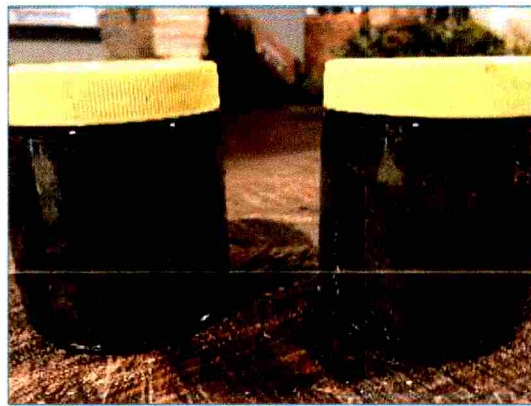
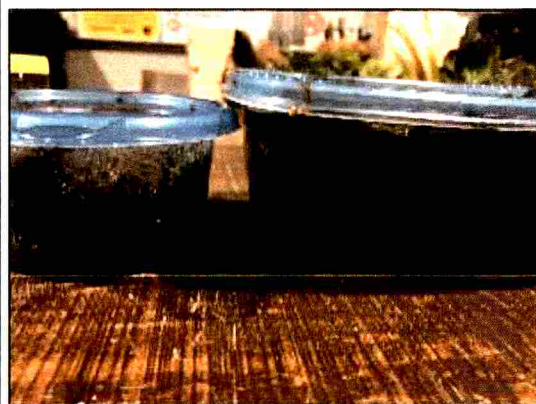
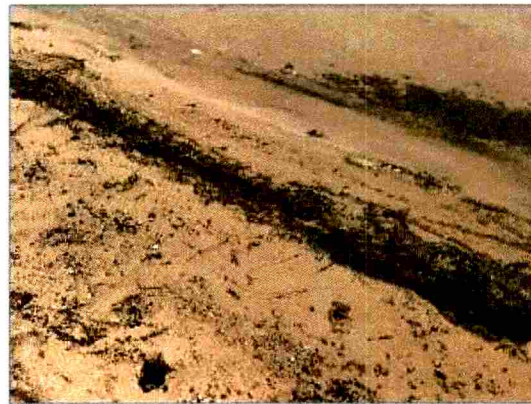
RLS collected a total of 7 samples with 3 collected in the canal, 2 in the main lake (out from the launch and point), and 2 onshore (Bayak Beach and Munising Beach) on September 13, 2018 (Figure 4). The samples were collected with an Ekman hand dredge, placed in sterile glass jars, and taken to Trace Analytical in Muskegon, Michigan to be analyzed for sediment organic matter percentage.

Canal and nearby bay

Nearshore samples

Beach samples (Bayak and Munising)

"Sludge" on beaches

Figure 4. Photos of sediment samples collected from the shoreline and lake bottom.

The canal sediment samples were all primarily fine silt and very dark in color with little sand. The open water samples (Southwest and Southeast Basins) were high in sands and low in fines. The samples collected onshore both resembled the Southwest and Southeast Basin samples. This means that the onshore “sludge” is likely originating from the lake and not the canal. This could indicate that strong wakes from wake boats may be transporting these solids from one part of the lake to another. Additional contributing factors could include intense storm events such as high winds and heavy downpours. RLS will provide educational recommendations in the annual lake progress report.

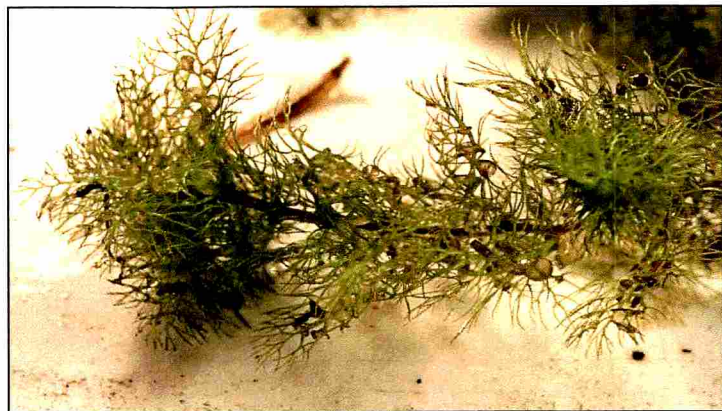
The most dominant aquatic plant species in June of 2018 included: 1) Leafless watermilfoil which appears as a small spike-like plant with fragile roots and has the appearance of sod on the lake bottom (Figure 5); 2) Common Bladderwort (Figure 6), which is bright green in color and has small clear bladders that trap zooplankton as a food source, and 3) Illinois Pondweed (Figure 7) which has a reddish-brown stem with slightly curled leaves and may form dense colonies in shallow areas and canals. All of the aforementioned aquatic plants are favorable and important components for the health of Big Star Lake.

Figure 6. Common Bladderwort

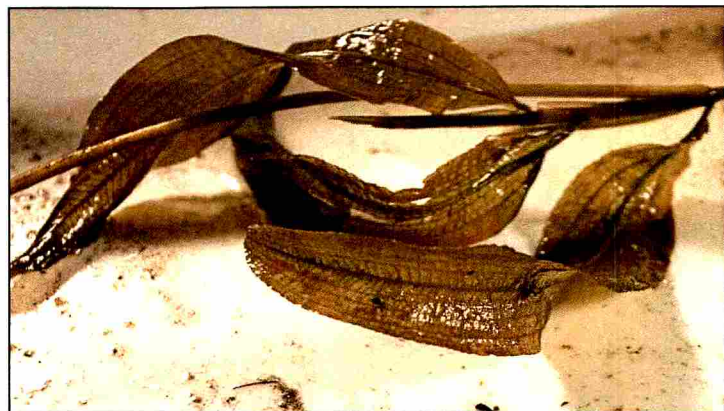
Figure 7. Illinois Pondweed

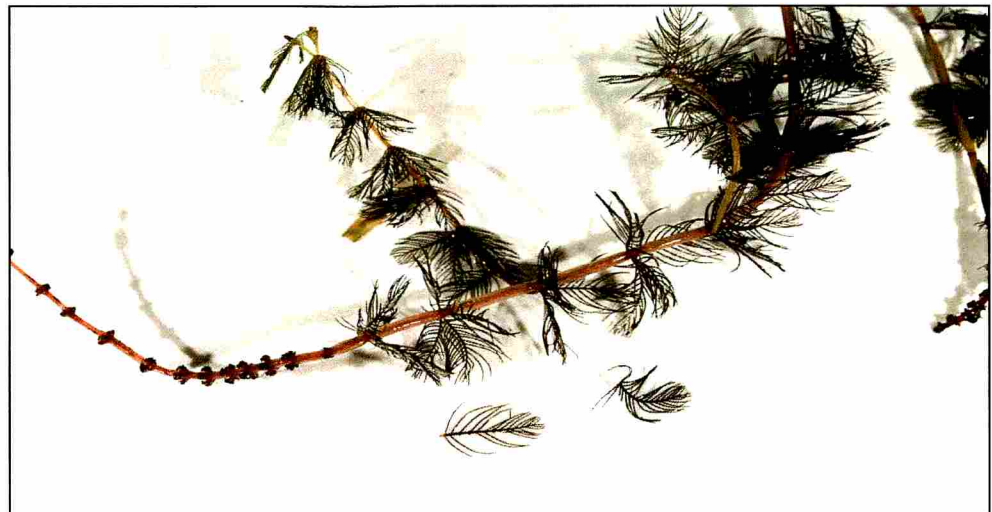
The amount of Eurasian Watermilfoil (Figure 8) present in Big Star Lake varies each year and is dependent upon climatic conditions, especially runoff-associated nutrients. In 2018, there were some intense rainfall events and this led to the transport of nutrients from the surrounding land to the lake water in many lakes and resulted in spikes of EWM and algae growth. In Big Star Lake the June 11, 2018 survey revealed that approximately 4.2 acres of milfoil was found throughout the entire lake plus less than two acres on the day of treatment. On June 25, the milfoil was treated with high dose granular triclopyr (Renovate OTF®) at a dose of 200 lbs/acre. The treatment was successful overall but late in the season another 9.0 acres of milfoil grew and also required a treatment with granular systemic herbicide which was conducted in early August.

Figure 8. Eurasian Watermilfoil

Aquatic vegetation surveys will be conducted in late May or early June with treatments to follow within a week or two. These surveys will prescribe treatments for EWM, CLP, and only nuisance native aquatic vegetation. During this survey, bottom scans of the lake will take place to determine changes in bottom hardness, hydrographic bottom contours and bio-mass of the existing vegetation. An additional survey after the treatment will determine the efficacy of the treatment and any follow-up treatments that may be needed. EWM will be treated with Renovate OTF® at 200 pounds/acre in near shore areas and Sculpin G® at 200 pounds/acre for areas more off-shore. Areas of less than an acre in size will be treated at 240 pounds/acre to better maintain herbicide contact in these areas. CLP will be treated with Aquathol K®. Diquat and/or Clipper® will be used on the nuisance native aquatic weeds if necessary. Areas in the wetlands near the boat launch and the marina will continue to be emphasized for possible treatment.
