Big Star Lake 2019 Aquatic Vegetation, Water Quality, and 2020 Management Recommendations Report

December, 2019

The following Big Star Lake report is a summary of key lake findings collected in 2019.

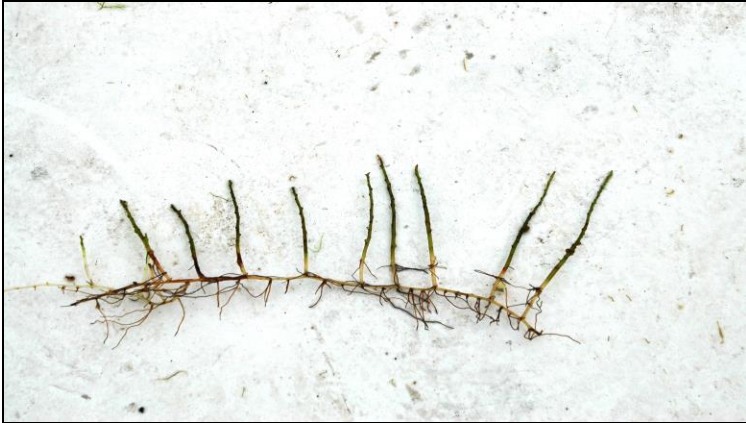
Figure 4. Leafless Watermilfoil

The most dominant aquatic plant species in June of 2019 included: 1) Leafless watermilfoil which appears as a small spike-like plant with fragile roots and has the appearance of sod on the lake bottom (Figure 4); 2) Common Bladderwort (Figure 5), which is bright green in color and has small clear bladders that trap zooplankton as a food source, and 3) the macro-alga Chara (Figure 6) which has a skunky odor and lies on the lake bottom. This macroalga is beneficial since it prevents EWM from rooting in the lake bottom and thus its growth is encouraged.

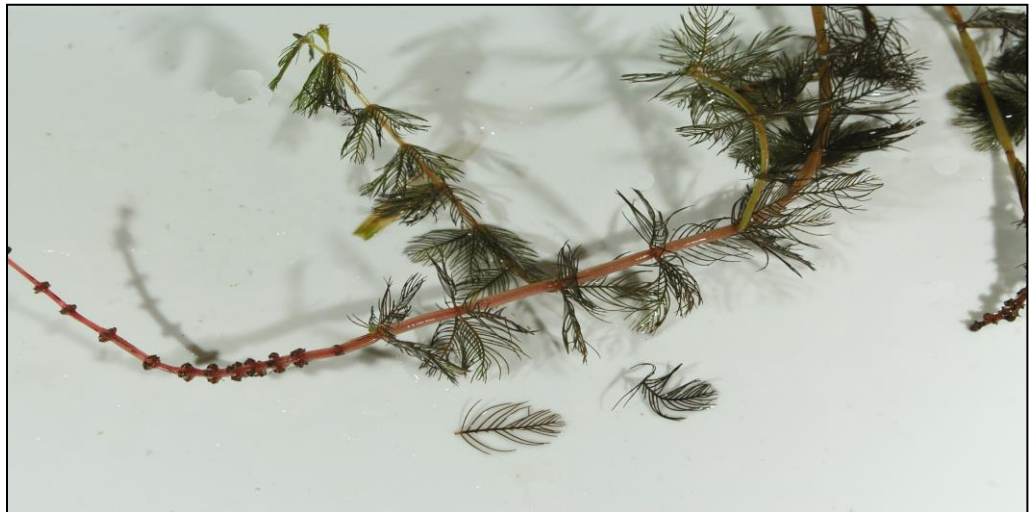
Figure 7. Eurasian Watermilfoil

The amount of Eurasian Watermilfoil (Figure 7) present in Big Star Lake varies each year and is dependent upon climatic conditions, especially runoff-associated nutrients. In 2019, the June 7, 2019 survey revealed that approximately 4.3 acres of milfoil was found throughout the entire lake. On June 18, 2019, the milfoil was treated with high dose granular triclopyr (Renovate OTF®) and Sculpin® where far enough offshore both at does of 230 lbs/acre. The treatment was very successful with no further treatments needed in 2019.
